Mountain Home Air Force Base
Photographs
November 15, 2007

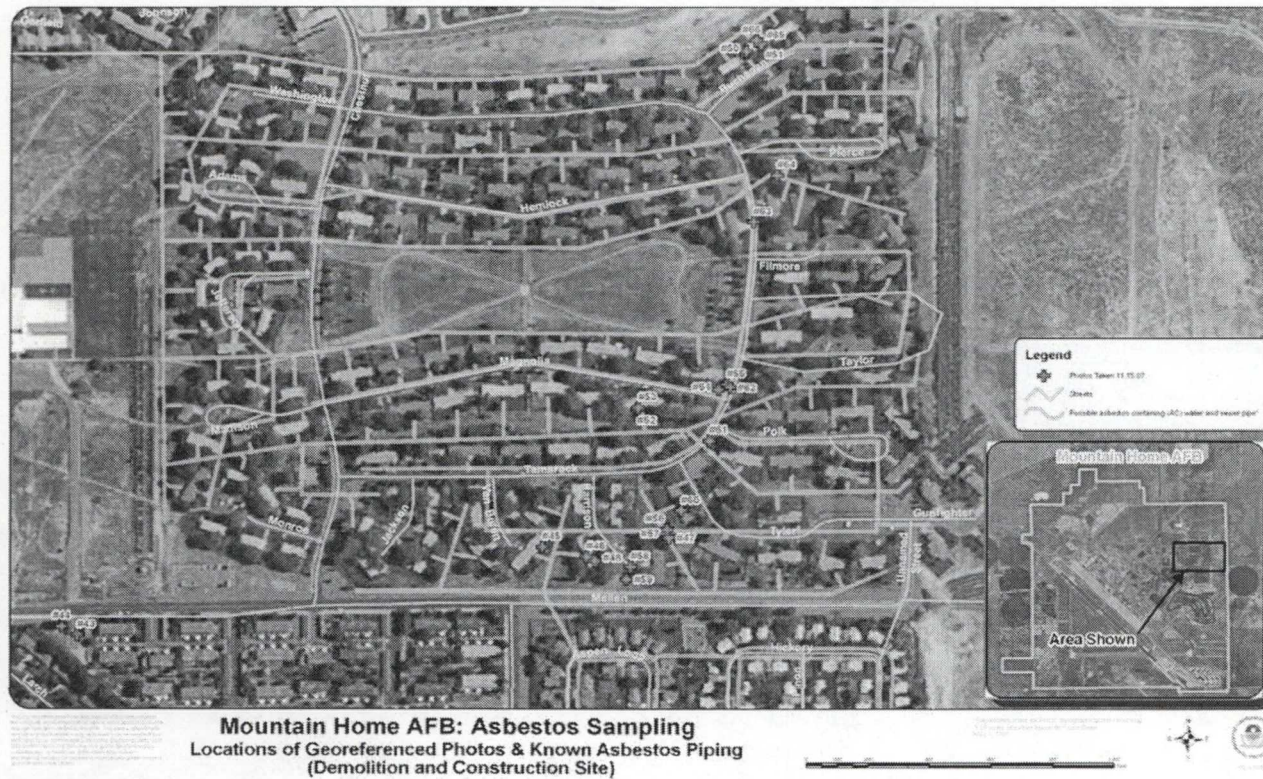
Figure 42 shows a few of the locations where the inspection team observed cement asbestos pipe at the Phase VI and Phase VII construction and demolition sites.

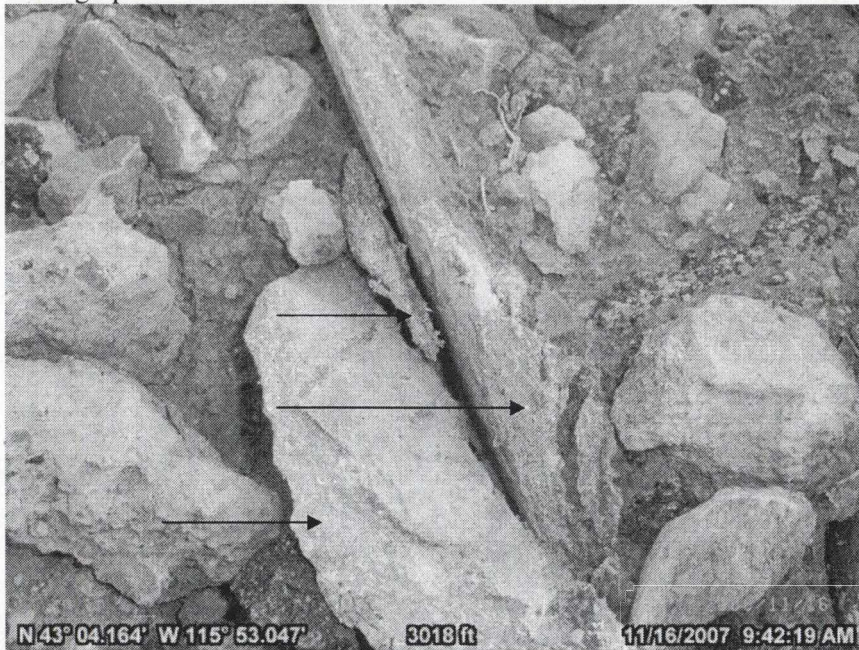
Figure 31 – Pieces of crumbled and fractured cement asbestos pipe (not sampled) at the Verlinde Hill Debris Field.

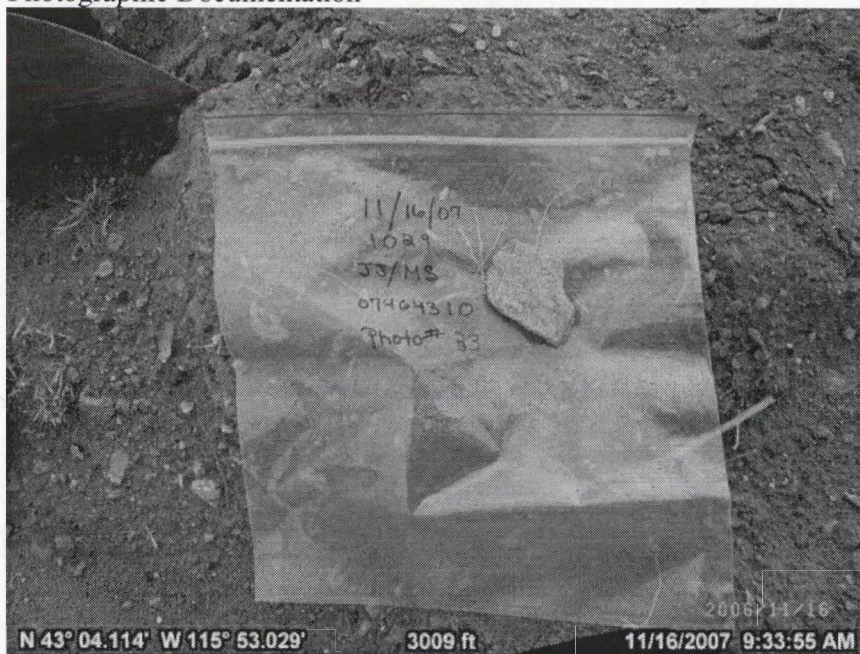
Figure 27 – Cement asbestos pipe fragment (Sample 07464310) found on the side of the pile approximately 3 ft below the surface of the pile at the Verlinde Hill Debris Field.

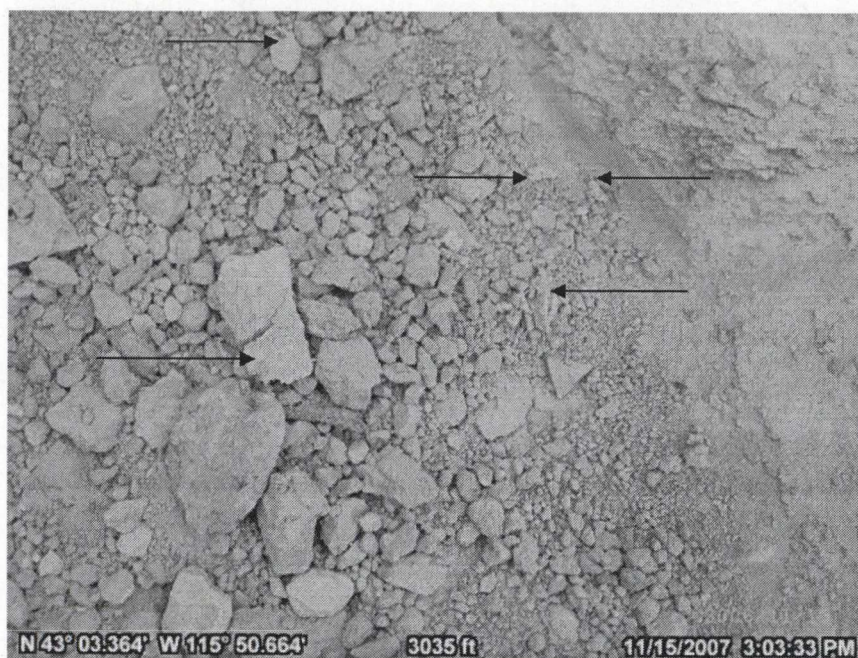
Figure 15 - Fragments of cement asbestos pipe (Sample 07464300) in open pit at the phase 6 construction site.

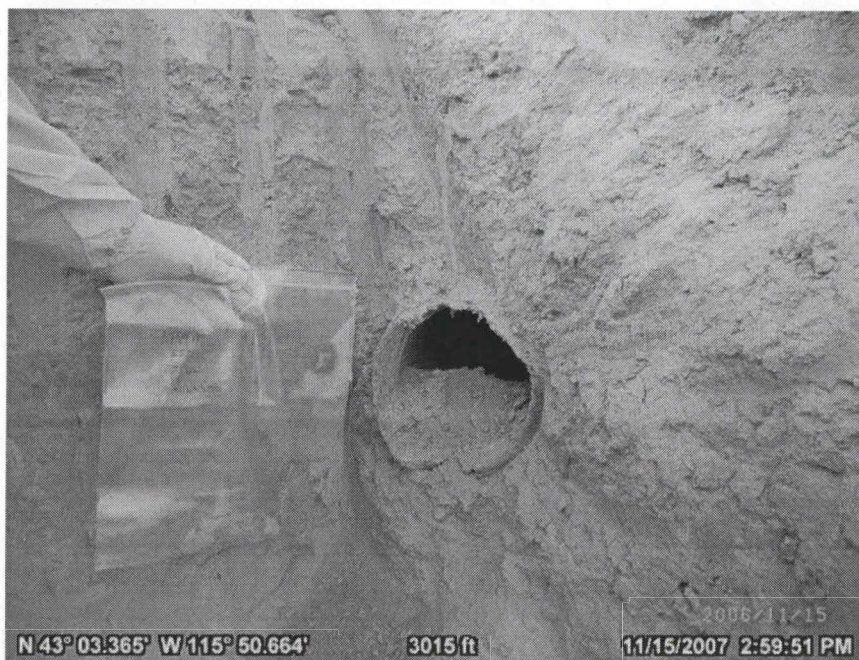
Figure 14 - Cement asbestos pipe (Sample 07464300) in open pit at the phase 6 construction site.
